**Flood Control Project Maintenance  
Levee Inspections**

## Maintenance Issue Types Only, Levee Inspection Report By Mile - Spring 2019

### Sutter Maintenance Yard Maintenance Area 0017

Waterway	Bank	Unit Miles	Inspection Start/End	Inspector
Unit No. 01 Lake County Sutter Maintenance Yard - Middle Creek	Left	3.87	04/04/2019 04/04/2019	Luz Dial

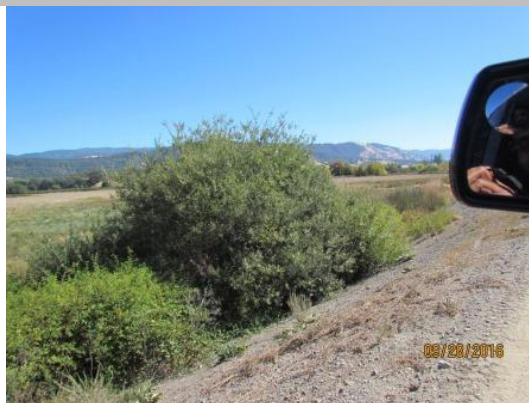
Photo 1 of 1 : SP\_2019\_MA0017\_339\_15\_20190307\_00003.jpg

LM Start	3.45	Rating **	M	Issue No.	15
LM End	3.84	Issue Type +	Ma	Location *	LS
Category	Earthen Levee			GPS Latitude/Longitude	
				Start	End
Item	Vegetation			39.148457 °	39.144620 °
				-122.911702 °	-122.906546 °
DWR ID	DWR_MA0017_01_s _ 2016_15				
Comment Code					
V2 : Remove the wild growth other than native grasses from the levee slopes.					
Inspector Comment					
Large bushes and brambles covering wire fence, limiting visibility and access.

View of the large bushes limiting visibility and access. Fall 2016

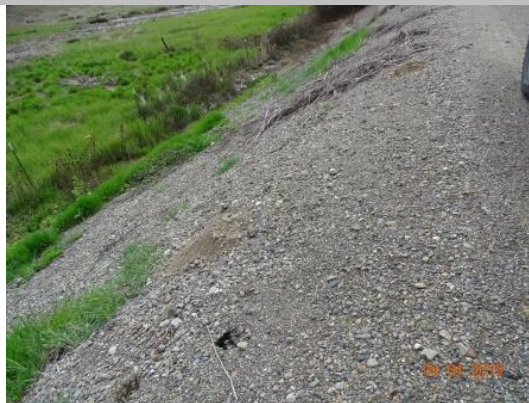
Photo 1 of 2 : SP\_2019\_MA0017\_339\_27\_20190405\_00047.jpg

LM Start	3.47	Rating **	M	Issue No.	27
LM End	3.47	Issue Type +	Ma	Location *	LS
Category	Earthen Levee			GPS Latitude/Longitude	
				Start	End
Item	Animal Control			39.148188 °	39.148188 °
				-122.911572 °	-122.911572 °
DWR ID	DWR_MA0017_01_s _ 2019_27				
Comment Code					
A3 : No rodents visible, but rodent burrows visible; need to backfill and compact or grout burrows.					
Inspector Comment

View looking downstream at animal holes on levee slope. Spring 2019

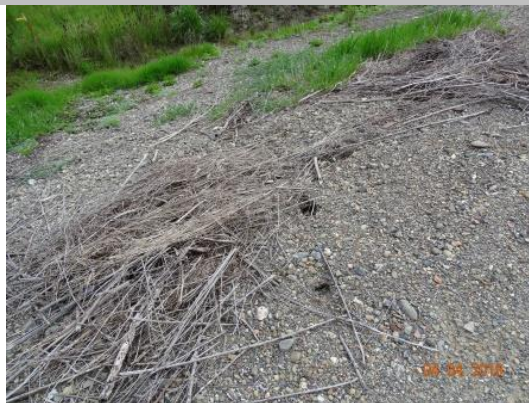
Photo 2 of 2 : SP\_2019\_MA0017\_339\_27\_20190405\_00048.jpg

LM Start	3.47	Rating **	M	Issue No.	27 (cont)	
LM End	3.47	Issue Type +	Ma	Location *	LS	
Category	Earthen Levee			GPS Latitude/Longitude		
				Start		End
Item	Animal Control			39.148188 °		39.148188 °
				-122.911572 °		-122.911572 °
DWR ID	DWR_MA0017_01_s _ 2019_27					
Comment Code						
A3 : No rodents visible, but rodent burrows visible; need to backfill and compact or grout burrows.						
Inspector Comment

View looking downstream at animal holes on levee slope. Spring 2019

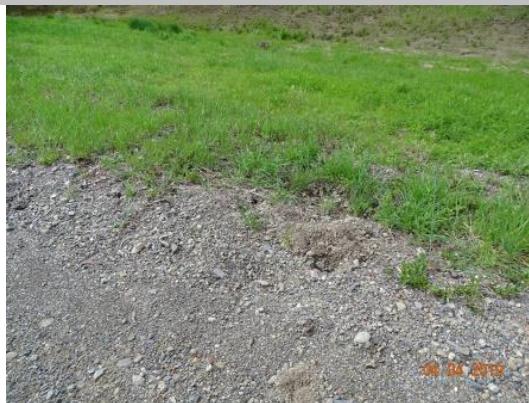
Photo 1 of 1 : SP\_2019\_MA0017\_339\_26\_20190405\_00046.jpg

LM Start	3.50	Rating **	M	Issue No.	26
LM End	3.50	Issue Type +	Ma	Location *	WS
Category	Earthen Levee			GPS Latitude/Longitude	
				Start	End
Item	Animal Control			39.147918 °	39.147918 °
				-122.911272 °	-122.911272 °
DWR ID	DWR_MA0017_01_s _ 2019_26				
Comment Code					
A1 : Exterminate rodents and backfill and compact or grout burrows.					
Inspector Comment					
There is evidence of recent animal activity.

View of animal holes on waterside shoulder. Spring 2019

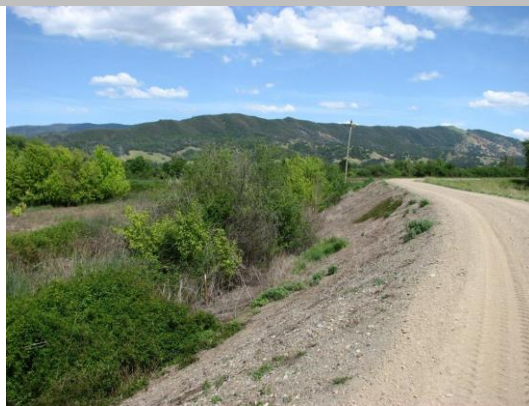
Photo 1 of 1 : SP\_2019\_MA0017\_339\_16\_20190307\_00004.jpg

LM Start	3.67	Rating **	M	Issue No.	16
LM End	4.03	Issue Type +	Ma	Location *	LS
Category	Earthen Levee			GPS Latitude/Longitude	
				Start	End
Item	Vegetation			39.146482 °	39.143585 °
				-122.908763 °	-122.903482 °
DWR ID	DWR_MA0017_01_s _ 2016_16				
Comment Code					
V2 : Remove the wild growth other than native grasses from the levee slopes.					
Inspector Comment					
Large bushes and brambles growing on wire fence on LS toe limiting visibility and access.

5/2/2016: Remove or trim dense vegetation growing on fence to allow visibility and access to L/S toe.

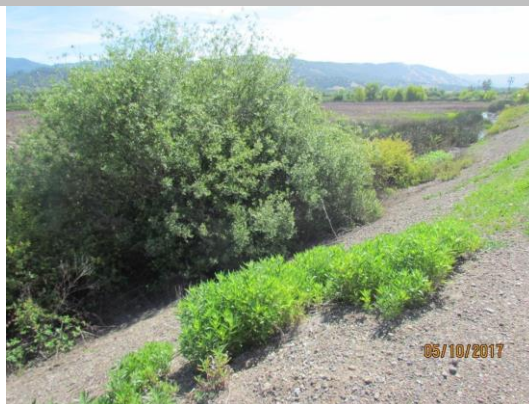
Photo 1 of 1 : SP\_2019\_MA0017\_339\_25\_20190307\_00007.jpg

LM Start	3.84	Rating **	M	Issue No.	25
LM End	3.84	Issue Type +	Ma	Location *	LS
Category	Earthen Levee			GPS Latitude/Longitude	
				Start	End
Item	Trim / Thin Trees			39.144695 °	39.144695 °
				-122.906668 °	-122.906668 °
DWR ID	DWR_MA0017_01_s _ 2017_25				
Comment Code					
T2 : Thin trees to allow visibility of the ground and room to flood fight.					
Inspector Comment					
Trim the trees along the landside toe.

View of the trees along the landside toe. Spring 2017

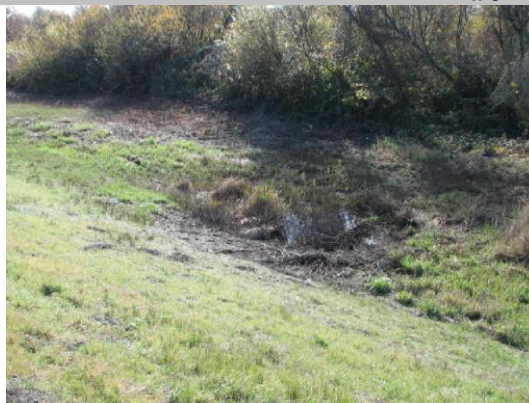
Photo 1 of 3 : UCIP\_SP\_2019\_50814\_46849.jpg

FS\_ID:50814  
DS\_ID:844  
EP\_NO: 11463  
Repair Type: No Action Needed  
Crossing Status: Found  
UCIP Comments: 10/19/2016 Crossing appears to be in good ondition.  
(DWR Sutter Yard- A Freitag)6/14/2016 crossing appears to be in good condition.4/23/2015 No issues with pipe.7/3/2014 Same as last inspection.12/23/2013 Same as last inspection.8/2/2013 New flap gate installed. No other issues with pipe.  
FIELD\_STRUCT\_DESC: 24-inch corrugated metal drainage pipe through the levee, 12.4 feet below the crown. Flap gate on the waterside (WS) end. Timber walkway on the landside (LS) slope to a timber walkway to pump house mounted on piles in drainage ditch. (24-inch pipe [HLM 3.99] authorized under Automatic Board Order (ABO) issued as Permit No. 11463, 1975 - Audrey Jones). [Additional Reference(s): DWR Levee Log, 2005. USACE Sacramento O&M Manual 506.2, August 1961, (HLM 3.99)].  
FS Date: 11/21/2016 12:09:38 PM

24-inch CMP at outlet on WS toe.

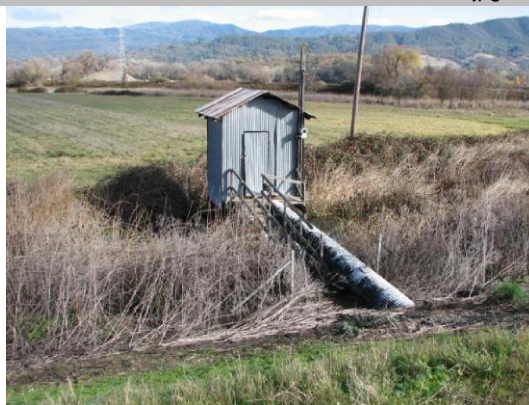
Photo 2 of 3 : UCIP\_SP\_2019\_50814\_46848.jpg

Pumphouse on piles at LS toe.

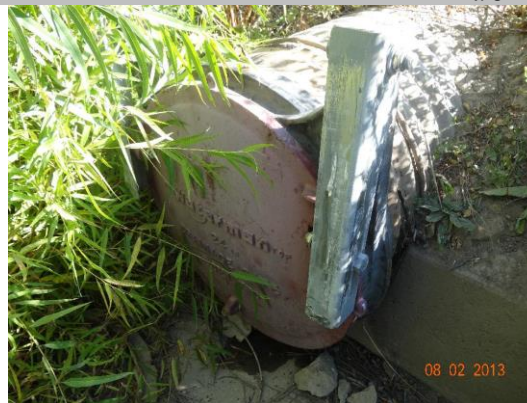
Photo 3 of 3 : UCIP\_SP\_2019\_50814\_46850.jpg

Comment Code						
Inspector Comment						
FS_ID:50814 DS_ID:844 EP_NO: 11463 Repair Type: No Action Needed Crossing Status: Found UCIP Comments: 10/19/2016 Crossing appears to be in good ondition. (DWR Sutter Yard- AFreitag)6/14/2016 crossing appears to be in good condition.4/23/2015 No issues with pipe.7/3/2014 Same as last inspection.12/23/2013 Same as last inspection.8/2/2013 New flap gate installed. No other issues with pipe. FIELD_STRUCT_DESC: 24-inch corrugated metal drainage pipe through the levee, 12.4 feet below the crown. Flap gate on the waterside (WS) end. Timber walkway on the landside (LS) slope to a timber walkway to pump house mounted on piles in drainage ditch. (24- inch pipe [HLM 3.99] authorized under Automatic Board Order (ABO) issued as Permit No. 11463, 1975 - Audrey Jones). [Additional Reference(s): DWR Levee Log, 2005. USACE Sacramento O&M Manual 506.2, August 1961, (HLM 3.99)]. FS Date: 11/21/2016 12:09:38 PM

New flap gate on WS

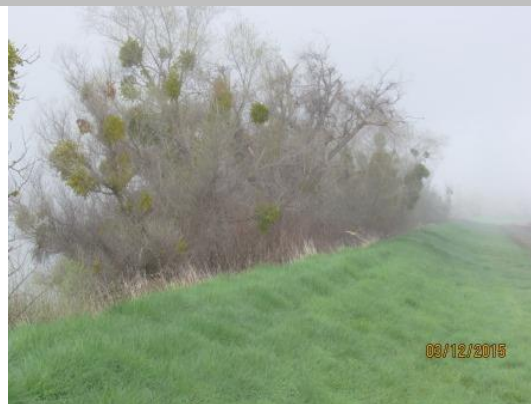
Photo 1 of 2 : SP\_2019\_MA0017\_339\_2\_20190307\_00001.jpg

LM Start	4.16	Rating **	U	Issue No.	2
LM End	7.10	Issue Type +	Ma	Location *	WS
Category	Earthen Levee			GPS Latitude/Longitude	
				Start	End
Item	Trim / Thin Trees			39.141894 °	39.120609 °
				-122.902201 °	-122.887166 °
DWR ID	DWR_MA0017_01_s_2012_2				
Comment Code					
T2 : Thin trees to allow visibility of the ground and room to flood fight.					
Inspector Comment					
Trees and limbs are completely obstructing visibility on crown and WS. Crown is too narrow to drive and overgrown with weeds, brush, and trees. Road follows LS toe.

View of the trees along the waterside slope and toe.

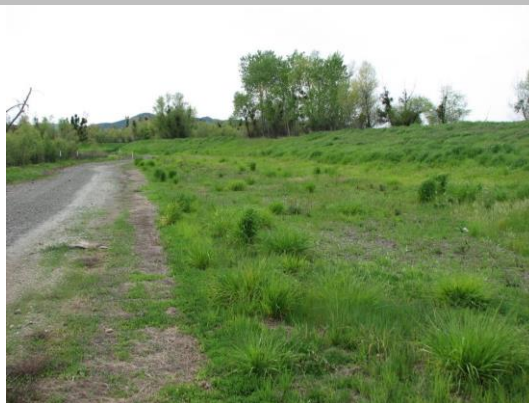
Photo 2 of 2 : SP\_2019\_MA0017\_339\_2\_20190307\_00002.jpg

Photo taken at LM 6.41 looking west showing overgrown LS slope of levee at right and toe road at left. Note trees obstructing visibility and access at levee crown. Crown is +/- 5 feet wide, and impassible to vehicles due to vegetation, and in some places, to pedestrians.  
4/19/2016

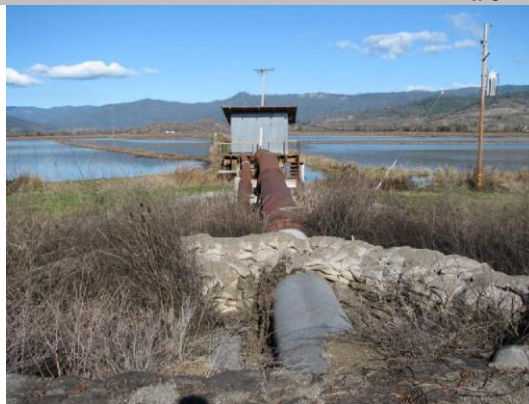
Photo 1 of 2 : UCIP\_SP\_2019\_50818\_46860.jpg

Comment Code					
Inspector Comment					
FS_ID:50818 DS_ID:847 EP_NO: 11469 Repair Type: Non-Urgent Crossing Status: Found UCIP Comments: 10/19/2016 Sack ring still in place. (DWR Sutter Yard- AFreitag)6/14/2016 Sack ring is still built up underneath the pipes.4/23/2015 Sack ring is still built up underneath the pipes.7/3/2014 Same as last inspection.12/23/2013 Same as last inspection.8/2/2013 Same as last inspection.12/13/2012 flood fight materials-ring levees around both LS and WS slopes at pipe crossing. This may or may not be an issue. FIELD_STRUCT_DESC: 1 of 2: 16-inch steel drainage pipe through the levee, 5 feet below the crown. Drainage pumping plant on the landside (LS). Flap gate on the waterside (WS) end. (one 16-inch and one 36-inch pipes [HLM 5.43] authorized under Automatic Board Order (ABO) issued as Permit No. 11469, 1975 - RD 2070). [Additional Reference(s): DWR Levee Log, 2005. USACE Sacramento O&M Manual 506.3, August 1961, (HLM 5.43)]. FS Date: 11/21/2016 12:11:57 PM

Pumping plant, pipes, and ring levees on LS toe.

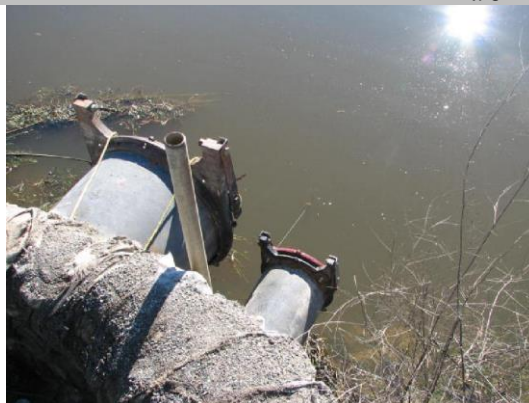
Photo 2 of 2 : UCIP\_SP\_2019\_50818\_46859.jpg

Comment Code						
Inspector Comment						
FS_ID:50818 DS_ID:847 EP_NO: 11469 Repair Type: Non-Urgent Crossing Status: Found UCIP Comments: 10/19/2016 Sack ring still in place. (DWR Sutter Yard- A Freitag)6/14/2016 Sack ring is still built up underneath the pipes.4/23/2015 Sack ring is still built up underneath the pipes.7/3/2014 Same as last inspection.12/23/2013 Same as last inspection.8/2/2013 Same as last inspection.12/13/2012 flood fight materials-ring levees around both LS and WS slopes at pipe crossing. This may or may not be an issue. FIELD_STRUCT_DESC: 1 of 2: 16-inch steel drainage pipe through the levee, 5 feet below the crown. Drainage pumping plant on the landside (LS). Flap gate on the waterside (WS) end. (one 16-inch and one 36-inch pipes [HLM 5.43] authorized under Automatic Board Order (ABO) issued as Permit No. 11469, 1975 - RD 2070). [Additional Reference(s): DWR Levee Log, 2005. USACE Sacramento O&M Manual 506.3, August 1961, (HLM 5.43)]. FS Date: 11/21/2016 12:11:57 PM

16-inch pipe, flap gate, air vent, and ring levee on WS slope.

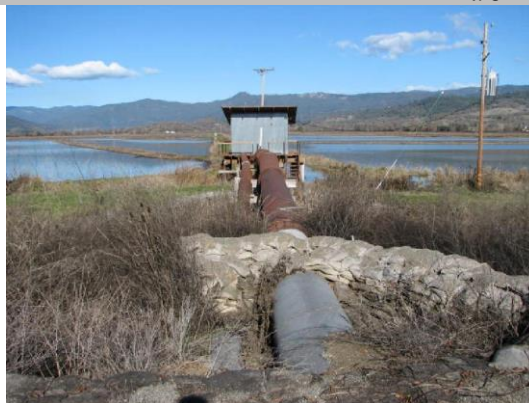
Photo 1 of 2 : UCIP\_SP\_2019\_50819\_46864.jpg

Comment Code						
Inspector Comment						
FS_ID:50819 DS_ID:853 EP_NO: 11469 Repair Type: Non-Urgent Crossing Status: Found UCIP Comments: 10/19/2016 Sack ring still in place. (DWR Sutter Yard- A Freitag)6/14/2016 Sack ring is still built up underneath the pipes.4/23/2015 Sack ring still built up underneath the pipes.7/3/2014 Same as last inspection.12/23/2013 Same as last inspection.8/2/2013 Same as last inspection.12/13/2012 flood fight materials-ring levees around both LS and WS slopes at pipe crossing. This may or may not be an issue. FIELD_STRUCT_DESC: 2 of 2: 36-inch steel drainage pipe through the levee, 5 feet below the crown. Flap gate and air vent on the waterside (WS) slope. (one 36-inch and one 16-inch pipes [HLM 5.43] authorized under Automatic Board Order (ABO) issued as Permit No. 11469, 1975 - RD 2070). [Additional Reference(s): DWR Levee Log, 2005. USACE Sacramento O&M Manual 506.3, August 1961, (HLM 5.43)]. FS Date: 11/21/2016 12:12:31 PM

Pipes and pump house on LS toe with ring levees.

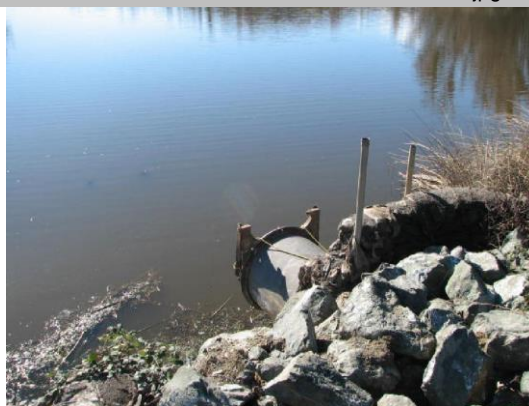
Photo 2 of 2 : UCIP\_SP\_2019\_50819\_46863.jpg

Pipe, flap gate, air vent, and sandbags on WS slope.

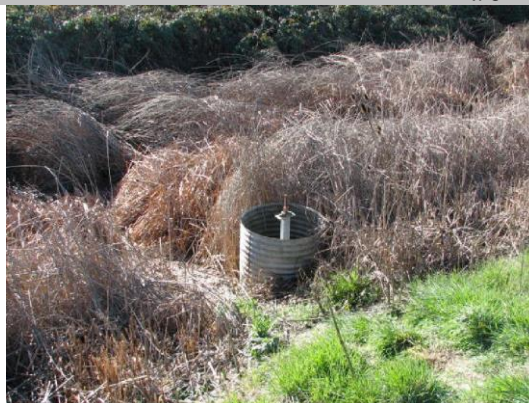
Photo 1 of 2 : UCIP\_SP\_2019\_50820\_46866.jpg

Comment Code					
Inspector Comment					
FS_ID:50820 DS_ID:848 EP_NO: 11457 Repair Type: Non-Urgent Crossing Status: Found UCIP Comments: 10/19/2016 No riser lid or slide gate wheel. (DWR Sutter Yard- A Freitag)6/14/2016 No riser lid and no wheel to operate screw gate.4/23/2015 No cover on riser and no wheel to operate gate.7/3/2014 Same as last inspection.12/23/2013 Same as last inspection.8/2/2013 Handle to operate gate was in place but still no cover on riser.12/13/2012 No cover on CMP riser and no handle for actuating gate. This may or may not be an issue. FIELD_STRUCT_DESC: 24-inch drainage pipe under patrol road and through the levee, 13.5 feet below the crown. Concrete "U" shaped headwall on the landside (LS) end. Slide gate in 36-inch corrugated metal pipe (CMP) riser on the waterside (WS) slope. Riser unit is mounted on concrete base. (24-inch pipe [HLM 5.87] authorized under Automatic Board Order (ABO) issued as Permit No. 11457, 1975 - Crawford). [Additional Reference(s): DWR Levee Log, 2005. USACE Sacramento O&M Manual 506.3, August 1961, (HLM 5.87)]. FS Date: 11/21/2016 12:12:57 PM

36-inch CMP riser and slide gate on WS slope.

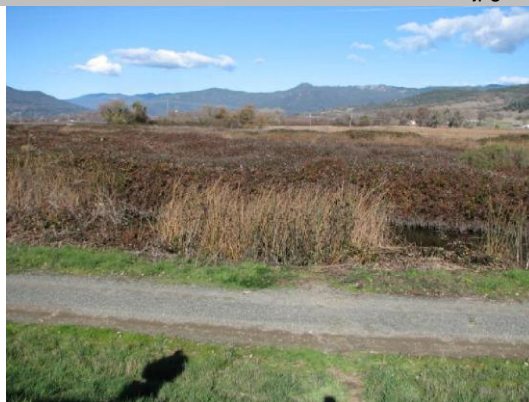
Photo 2 of 2 : UCIP\_SP\_2019\_50820\_46865.jpg

Approximate location of inlet on LS toe (not visible).

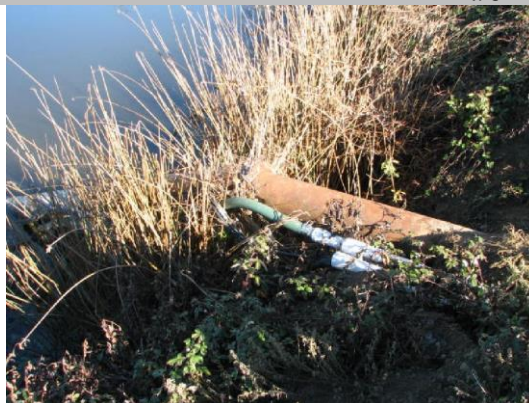
Photo 1 of 3 : UCIP\_SP\_2019\_53323\_46882.jpg

FS\_ID:53323  
DS\_ID:850  
EP\_NO: 11467  
Repair Type: Urgent  
Crossing Status: Found  
UCIP Comments: 9/6/18 Same as last inspection; WS erosion is still present so the crossing remains Urgent (D. Sanoski - DWR UCIP).10/19/2016 WS erosion still present. (DWR Sutter Yard - AFreitag)6/14/2016 WS erosion is still present. (DWR Sutter Yard - afreitag)4/23/2015 Same as last inspection. (DWR Sutter Yard - afreitag)7/3/2014 Same as last inspection. (DWR Sutter Yard - afreitag)12/23/2013 Same as last inspection. (DWR Sutter Yard - afreitag)8/2/2013 Same as last inspection. (DWR Sutter Yard - afreitag)12/13/2012 This pipe and appurtenances do not match what was described in the permit (PN: 11467). Does not appear to be in compliance with board regulations. (DWR UCIP - wwylie)  
FIELD\_STRUCT\_DESC: 12-inch steel drainage pipe through the levee, 2 feet below the crown. Butterfly valve on the landside (LS) shoulder. Pump and electrical panel, along with multiple valves and appurtenances, on the LS shoulder. (12-inch pipe [HLM 6.11] authorized under Automatic Board Order (ABO) issued as Permit No. 11467, 1975 - B. F. Modglin). [Additional Reference(s): DWR Levee Log, 2005. USACE Sacramento O&M Manual 506.3, 1967, (HLM 6.11)].

12-inch pipe and appurtenances on WS shoulder.

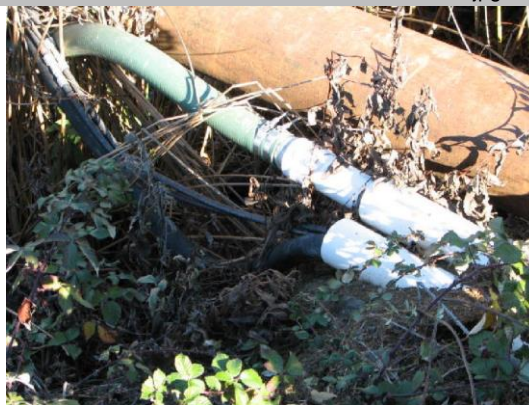
Photo 2 of 3 : UCIP\_SP\_2019\_53323\_46881.jpg

12-inch pipe and appurtenances on WS shoulder.

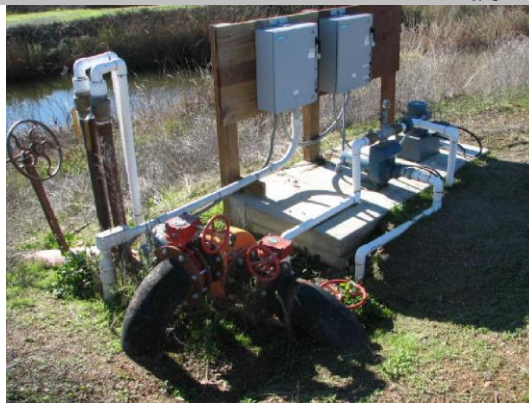
Photo 3 of 3 : UCIP\_SP\_2019\_53323\_46880.jpg

Item	DWR UCIP LMA Responsibility		39.126027 °	39.126027 °								
			-122.883371 °	-122.883371 °								
DWR ID	850											
Comment Code												
Inspector Comment												
FS_ID:53323 DS_ID:850 EP_NO: 11467 Repair Type: Urgent Crossing Status: Found UCIP Comments: 9/6/18 Same as last inspection; WS erosion is still present so the crossing remains Urgent (D. Sanoski - DWR UCIP).10/19/2016 WS erosion still present. (DWR Sutter Yard - A Freitag)6/14/2016 WS erosion is still present. (DWR Sutter Yard - a Freitag)4/23/2015 Same as last inspection. (DWR Sutter Yard - a Freitag)7/3/2014 Same as last inspection. (DWR Sutter Yard - a Freitag)12/23/2013 Same as last inspection. (DWR Sutter Yard - a Freitag)8/2/2013 Same as last inspection. (DWR Sutter Yard - a Freitag)12/13/2012 This pipe and appurtenances do not match what was described in the permit (PN: 11467). Does not appear to be in compliance with board regulations. (DWR UCIP - wwylie) FIELD_STRUCT_DESC: 12-inch steel drainage pipe through the levee, 2 feet below the crown. Butterfly valve on the landside (LS) shoulder. Pump and electrical panel, along with multiple valves and appurtenances, on the LS shoulder. (12-inch pipe [HLM 6.11] authorized under Automatic Board Order (ABO) issued as Permit No. 11467, 1975 - B. F. Modglin). [Additional Reference(s): DWR Levee Log, 2005. USACE Sacramento O&M Manual 506.3, 1967, (HLM 6.11)]. FS Date: 9/6/2018 10:48:00 AM

Pumping plant and appurtenances on LS shoulder.

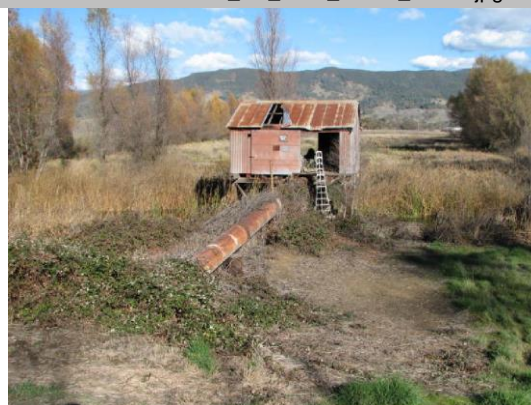
Photo 1 of 2 : UCIP\_SP\_2019\_50827\_46884.jpg

Comment Code					
Inspector Comment					
FS_ID:50827 DS_ID:851 EP_NO: 11467 Repair Type: Non-Urgent Crossing Status: Found UCIP Comments: 10/19/2016 Abandoned- should be done so properly. (DWR Sutter Yard- A/Freitag)6/14/2016 Abandoned crossing.4/23/2015 Same as last inspection. Pipe still needs to be properly abandoned.7/3/2014 Same as last inspection.12/23/2013 Same as last inspection.8/2/2013 Same as last inspection.12/13/2012 Pipe should be properly abandoned. FIELD_STRUCT_DESC: *ABANDONED* 1 of 2: 16-inch steel drainage pipe through the levee, 8 feet below the crown. Drainage pumping plant on the landside (LS). Flap gate on the waterside (WS) end. Steel plate welded on end of pipe at LS toe. (one 16-inch and one 24-inch pipes [HLM 7.79] authorized under Automatic Board Order (ABO) issued as Permit No. 11467, 1975 - Modglin). [Additional Reference(s): DWR Levee Log, 2005. USACE Sacramento O&M Manual 506.3, August 1961, (HLM 7.19)]. FS Date: 11/21/2016 12:16:52 PM

Pumping plant in shed on LS at drainage ditch.

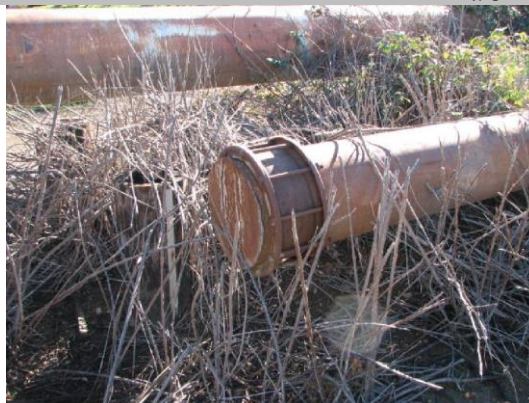
Photo 2 of 2 : UCIP\_SP\_2019\_50827\_46883.jpg

Comment Code					
Inspector Comment					
FS_ID:50827 DS_ID:851 EP_NO: 11467 Repair Type: Non-Urgent Crossing Status: Found UCIP Comments: 10/19/2016 Abandoned- should be done so properly. (DWR Sutter Yard- A Freitag)6/14/2016 Abandoned crossing.4/23/2015 Same as last inspection. Pipe still needs to be properly abandoned.7/3/2014 Same as last inspection.12/23/2013 Same as last inspection.8/2/2013 Same as last inspection.12/13/2012 Pipe should be properly abandoned. FIELD_STRUCT_DESC: *ABANDONED* 1 of 2: 16-inch steel drainage pipe through the levee, 8 feet below the crown. Drainage pumping plant on the landside (LS). Flap gate on the waterside (WS) end. Steel plate welded on end of pipe at LS toe. (one 16-inch and one 24-inch pipes [HLM 7.79] authorized under Automatic Board Order (ABO) issued as Permit No. 11467, 1975 - Modglin). [Additional Reference(s): DWR Levee Log, 2005. USACE Sacramento O&M Manual 506.3, August 1961, (HLM 7.19)]. FS Date: 11/21/2016 12:16:52 PM

Steel plate welded over end of pipe at LS toe.
